# Structural Assessment Report

10 December 2013

**United Scanning Services Pty Ltd**

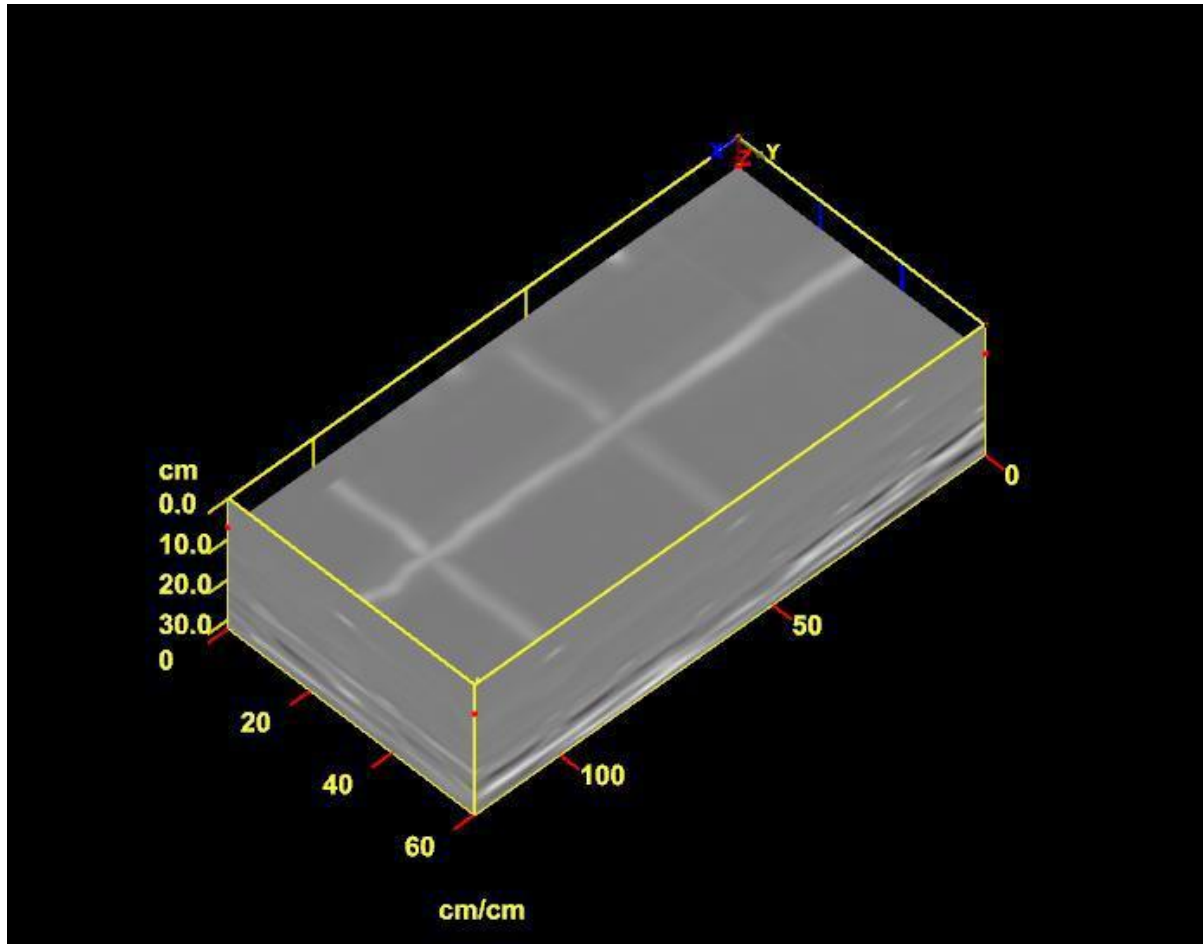
An Example of the re-bars found in the slab in 3D mode
