Structural Assessment Report

10 December 2013

United Scanning Services Pty Ltd

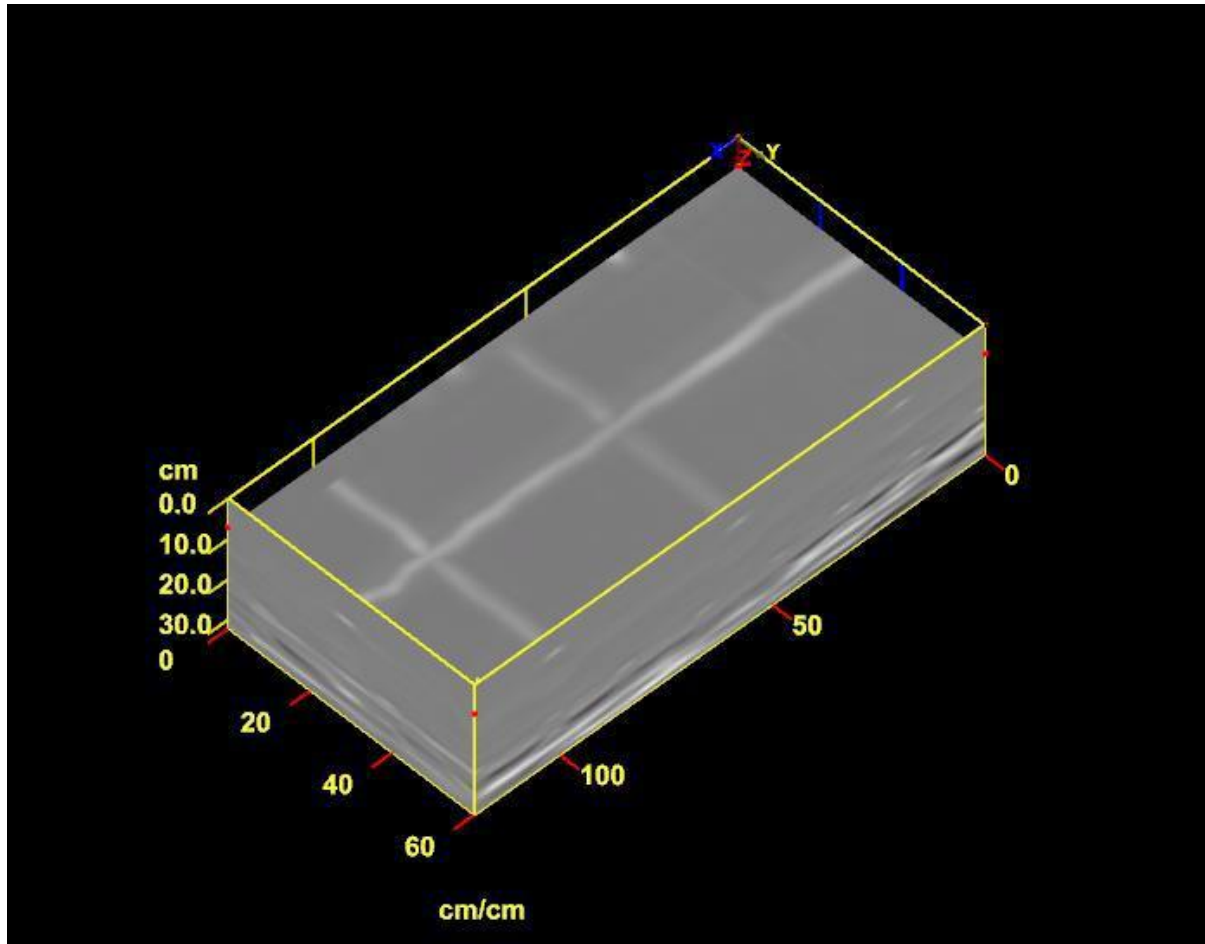
An Example of the re-bars found in the slab in 3D mode
