UNITED SCANNING  
SERVICES PTY LTD

## Camera Inspection and Mortar Test

Undertook camera inspections in requested areas where client had drilled holes to determine wall properties and record findings. Undertook scratch testing of mortar joints in requested areas to determine mortar rating/scratch index.

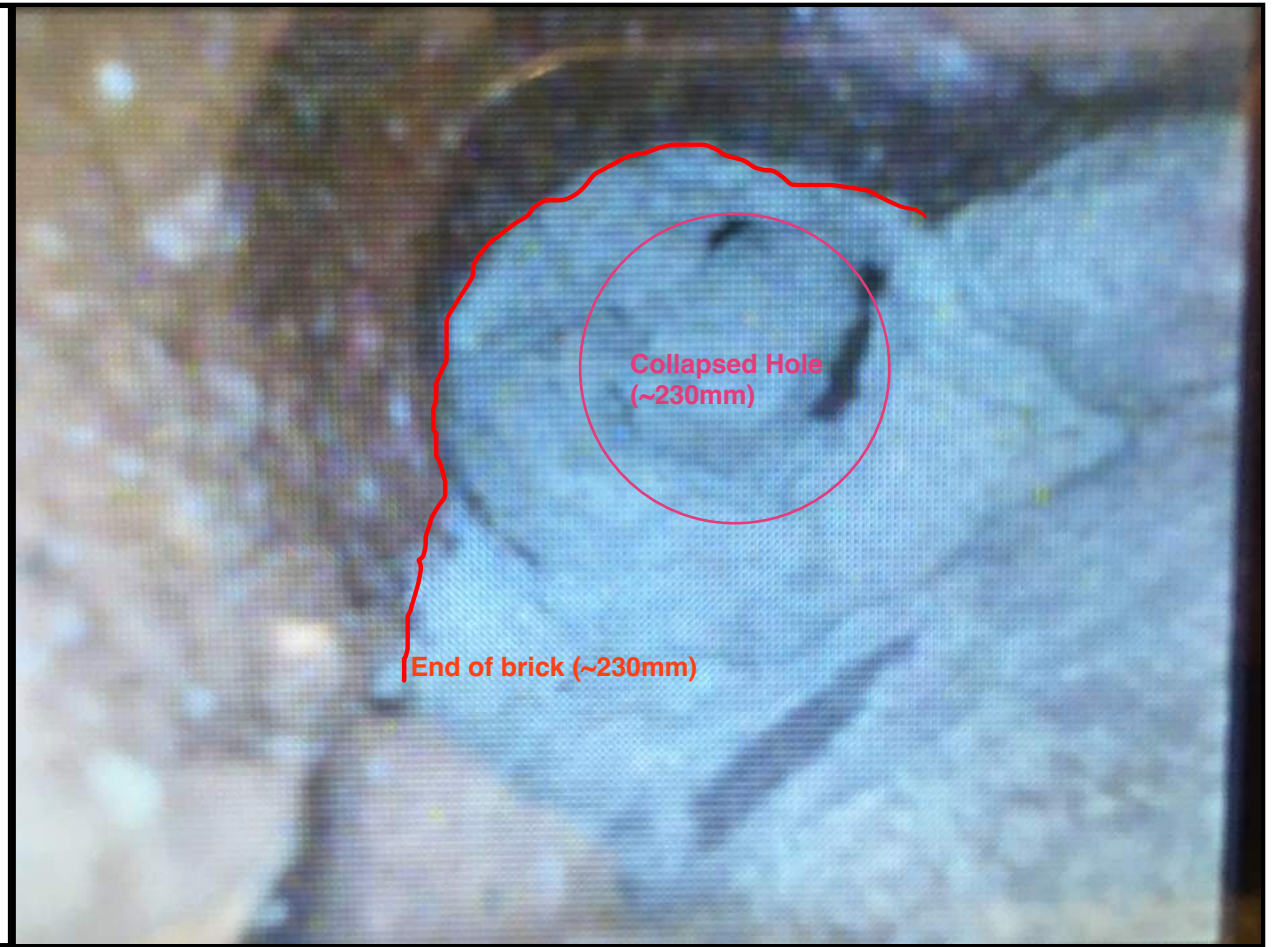
#### Camera Inspection 1

~0-230mm appeared to be solid brick (no mortar joints seen)

~230mm deep there appeared to be mortar, hole was collapsed and camera could not be pushed further.

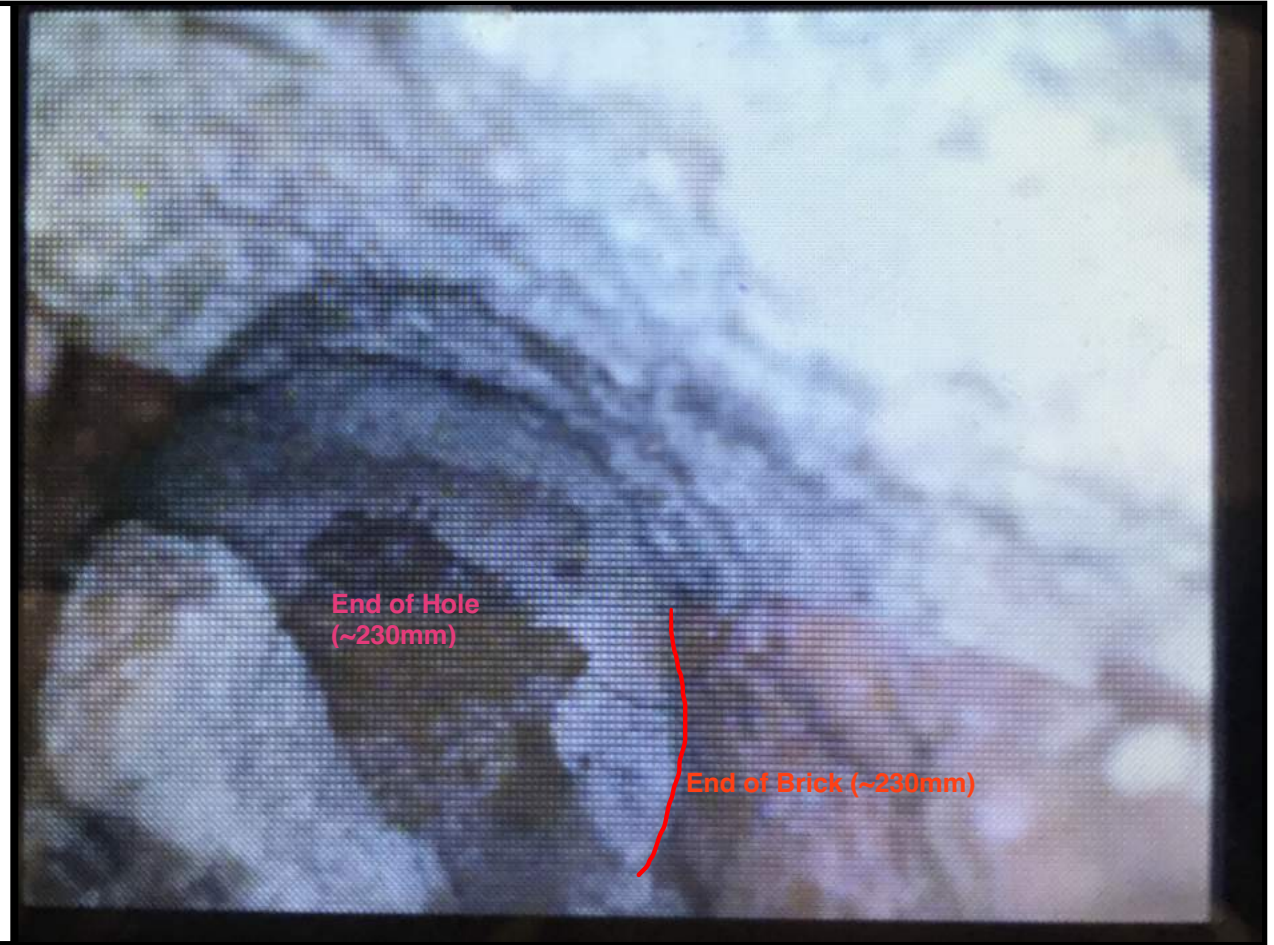
#### Camera Inspection 2

~0-230mm appeared to be solid brick (no mortar joints seen)  
~230mm deep there appeared to be mortar and a very small cavity estimated <10mm, hole had not been drilled any further.

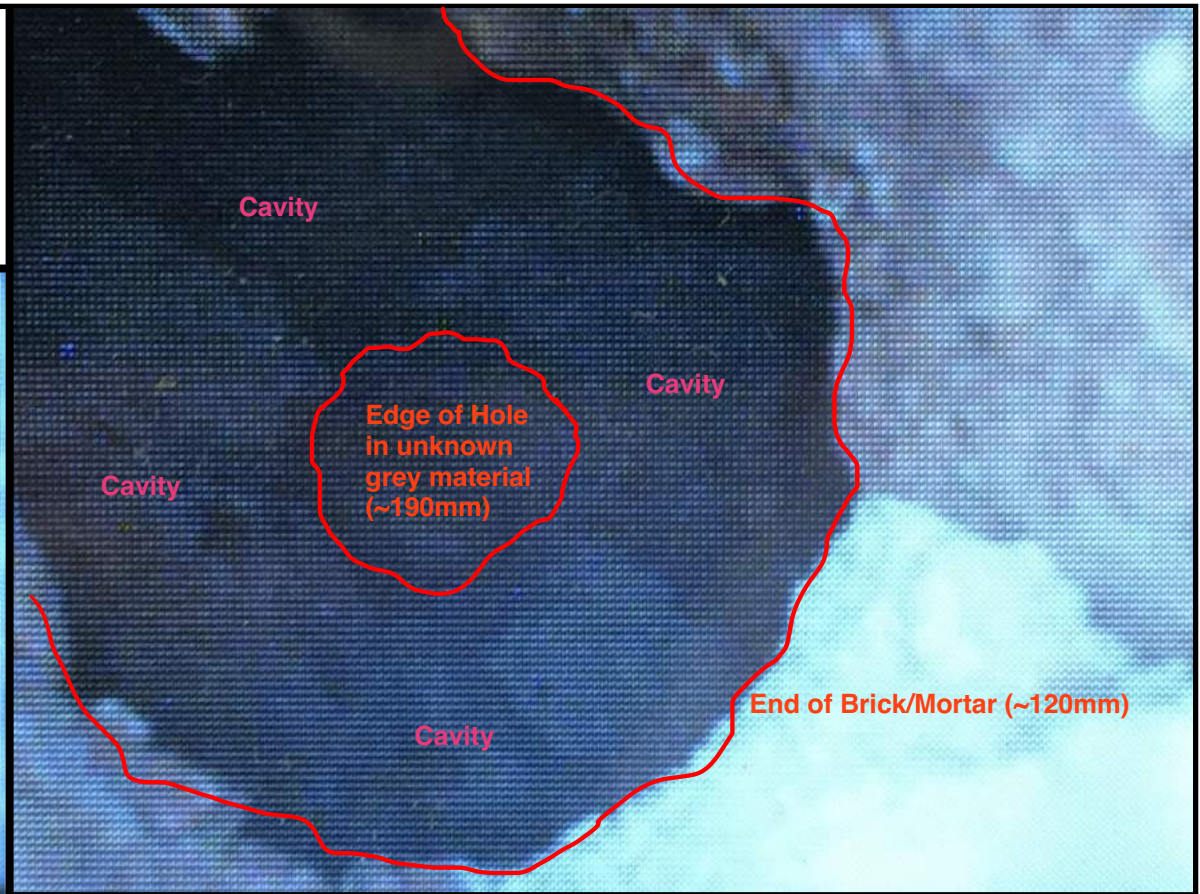
Camera Inspection 3  
~0-120mm appeared to be solid brick (no mortar joints seen)  
~120-190mm appeared to be a complete void  
~190-255mm appeared to be an unknown grey material  
(possibly concrete)  
~255mm end of hole

This image shows the unknown grey material (possibly concrete) encountered from ~190-255mm deep

End of Hole  
(~255mm)

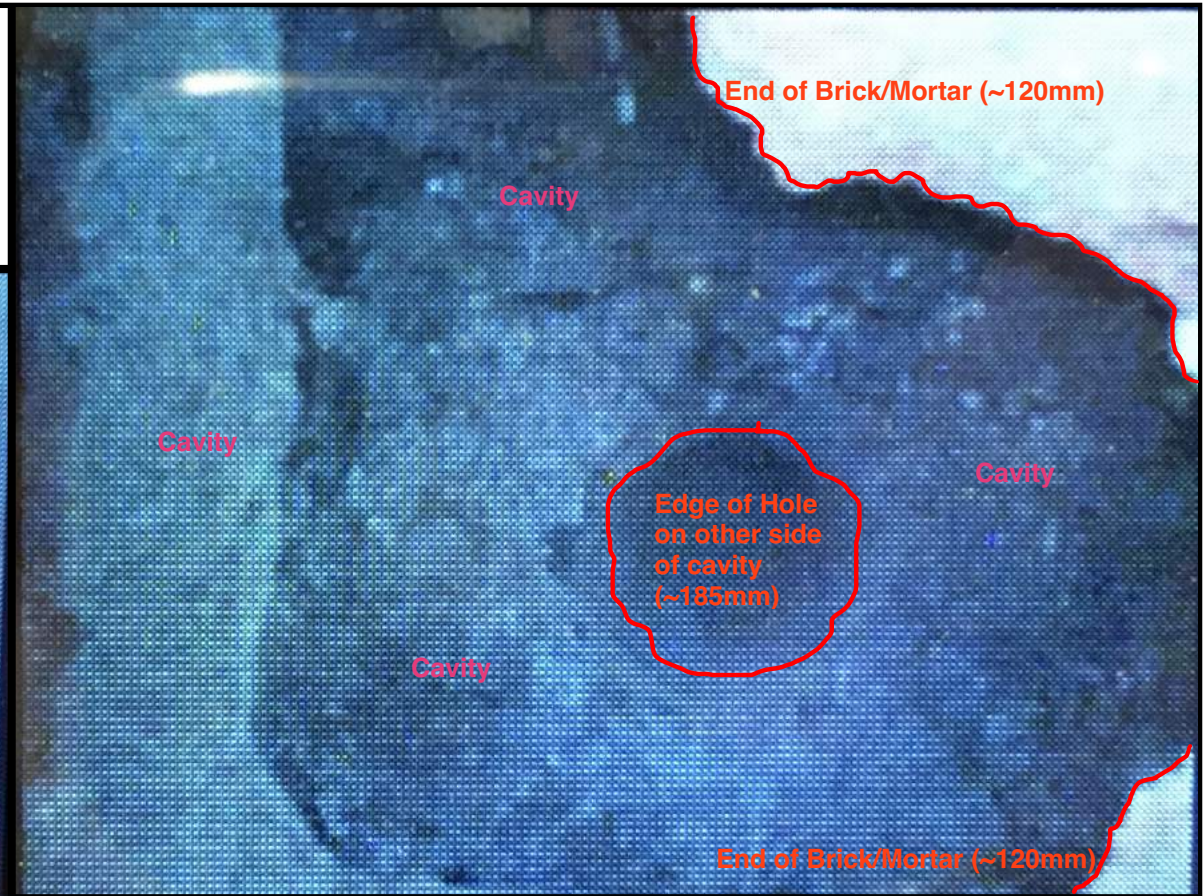
#### Camera Inspection 4

~0-120mm appeared to be solid brick (no mortar joints seen)  
~120-185mm appeared to be a complete void  
~185-250mm appeared to be brick  
~250mm end of hole

This image appears to be a grey material, however, this was red and appeared to be brick.

End of Hole  
(~250mm)

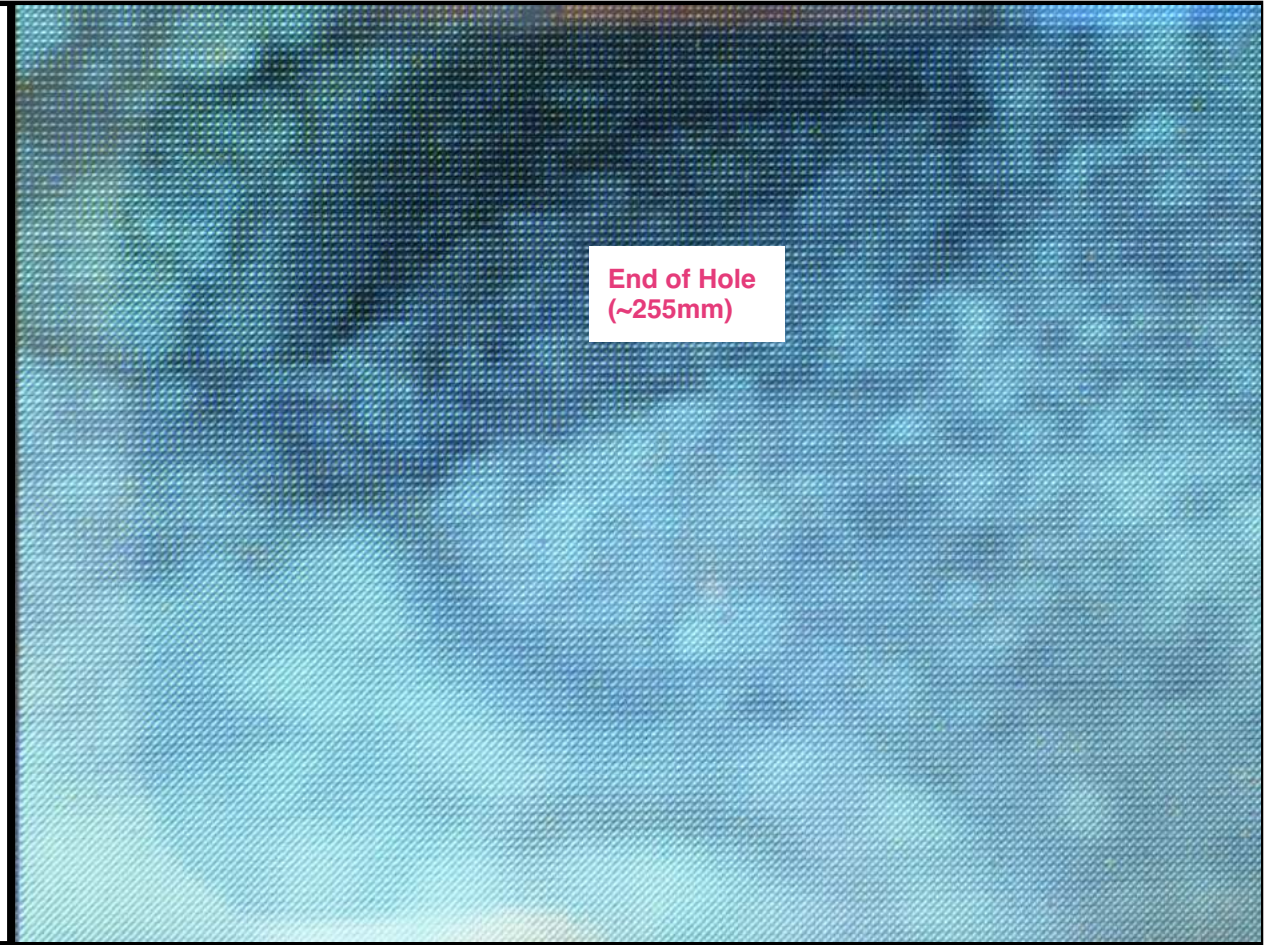
Camera Inspection 5  
~0-255mm appeared to be solid brick (no voids or cavities seen)  
~255mm end of hole

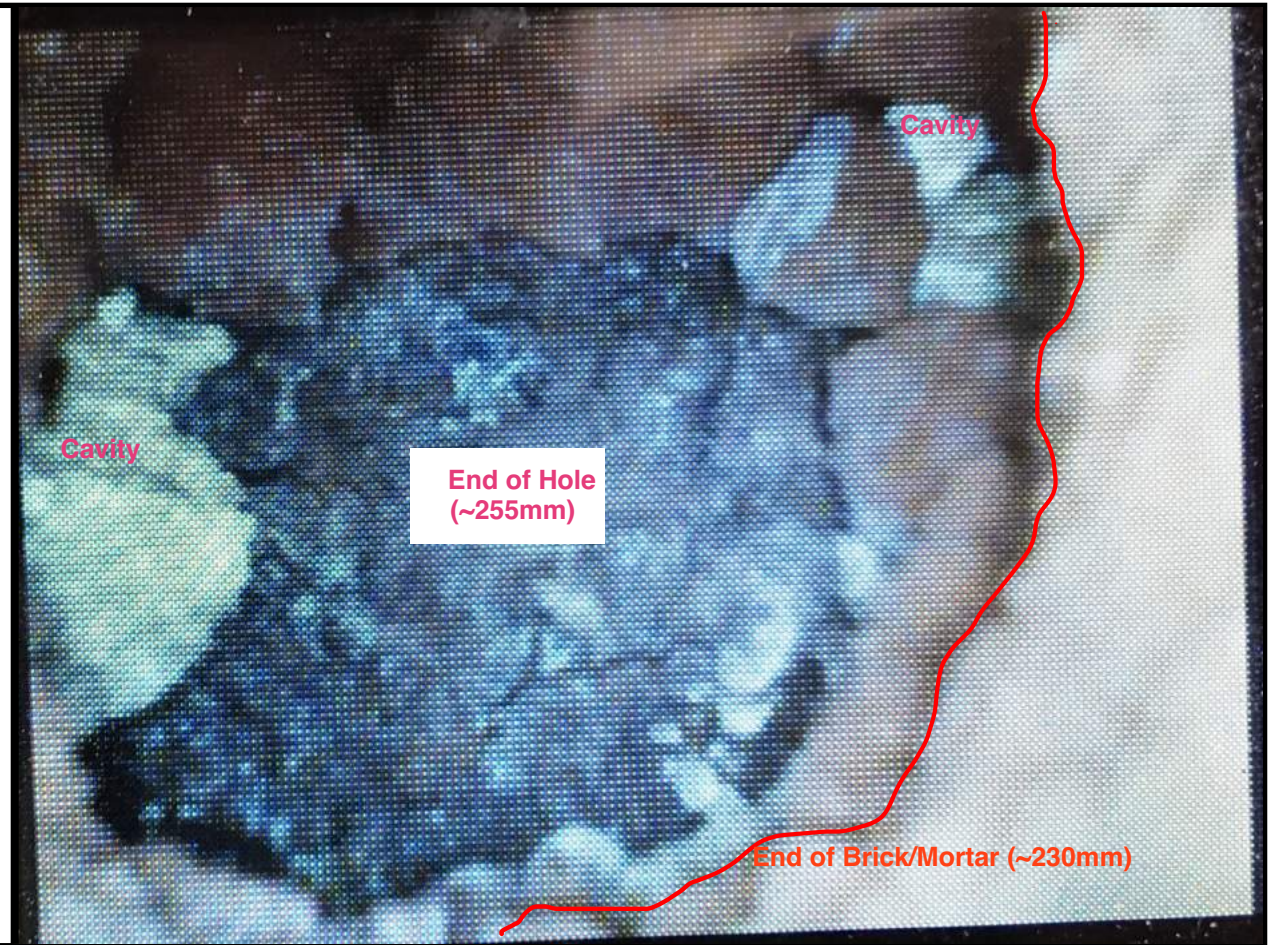
#### Camera Inspection 6

~0-230mm appeared to be solid brick (no voids or cavities seen)

~230-255mm appeared to be a small cavity

~255mm end of hole

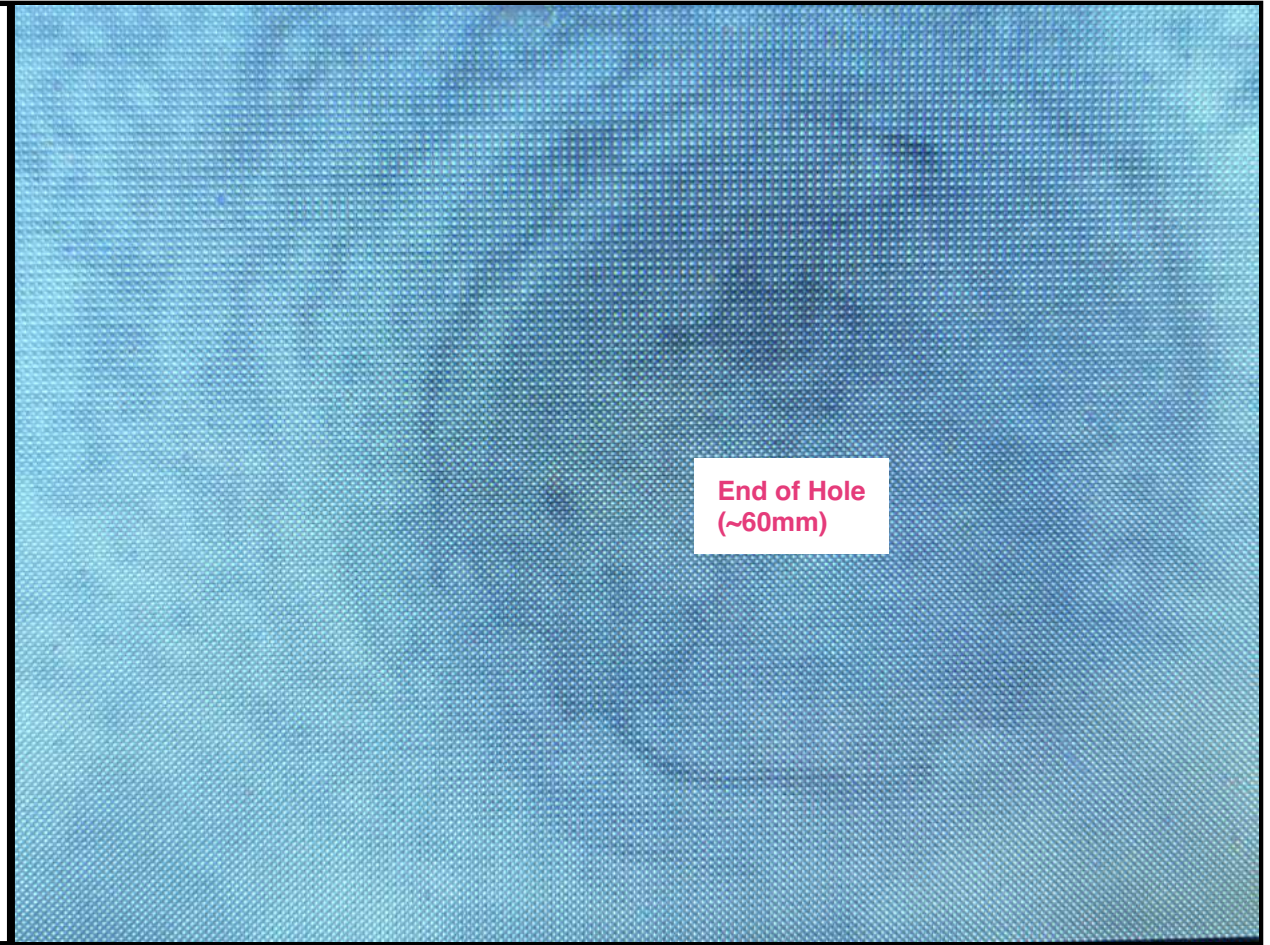
Camera Inspection 7  
~0-60mm appeared to be solid render/concrete  
~60mm end of hole

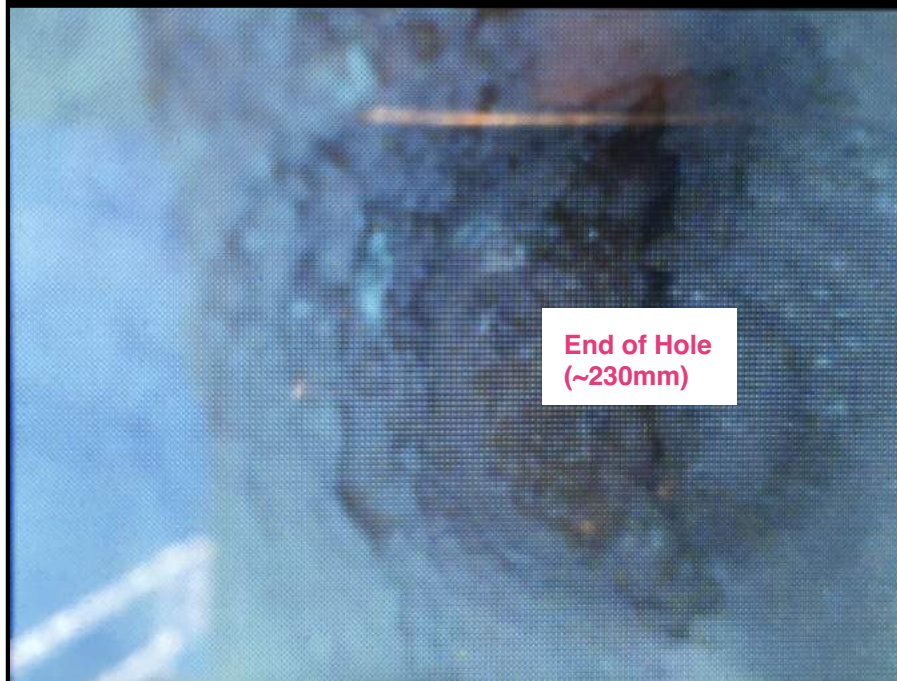
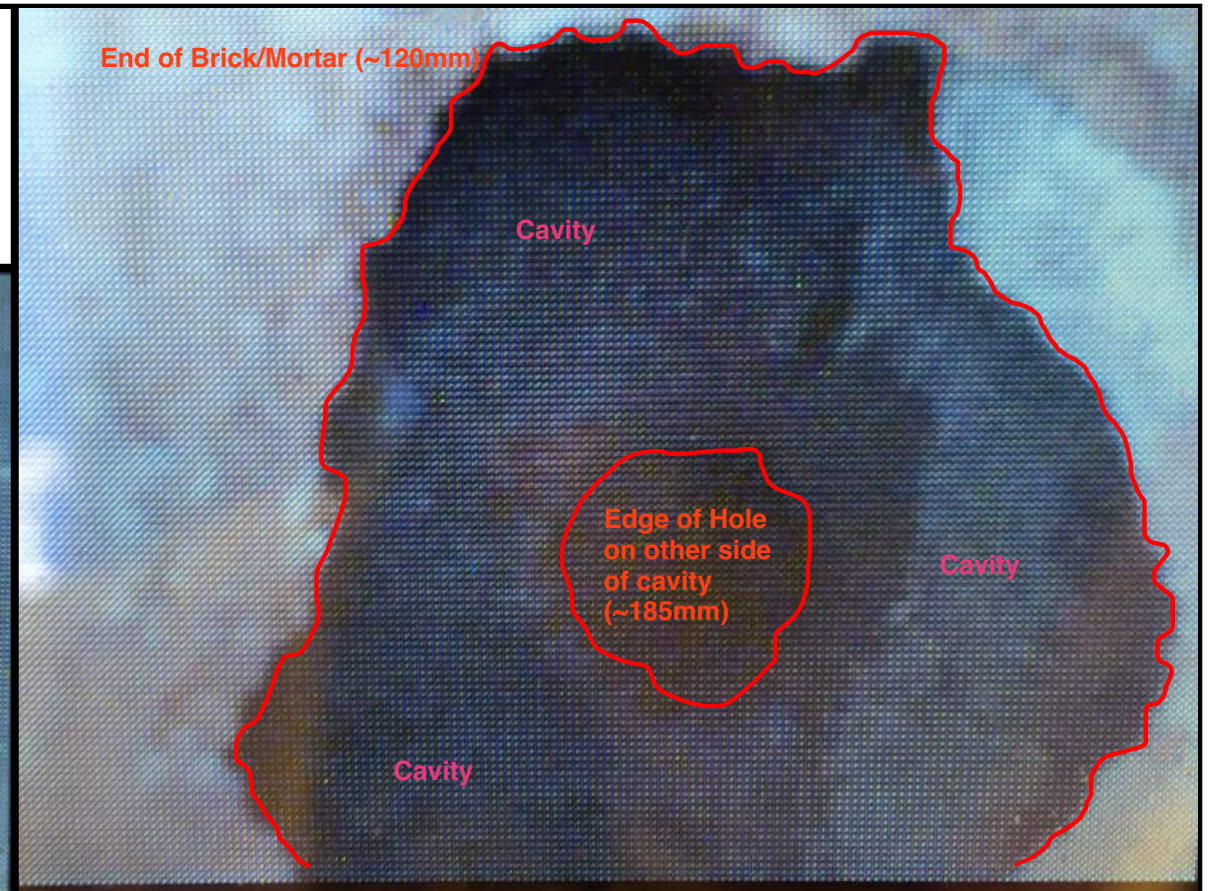
#### Camera Inspection 8

~0-130mm appeared to be solid brick (no voids or cavities seen)

~130-185mm appeared to be a cavity

~185-230mm appeared to be solid brick

~230mm end of hole

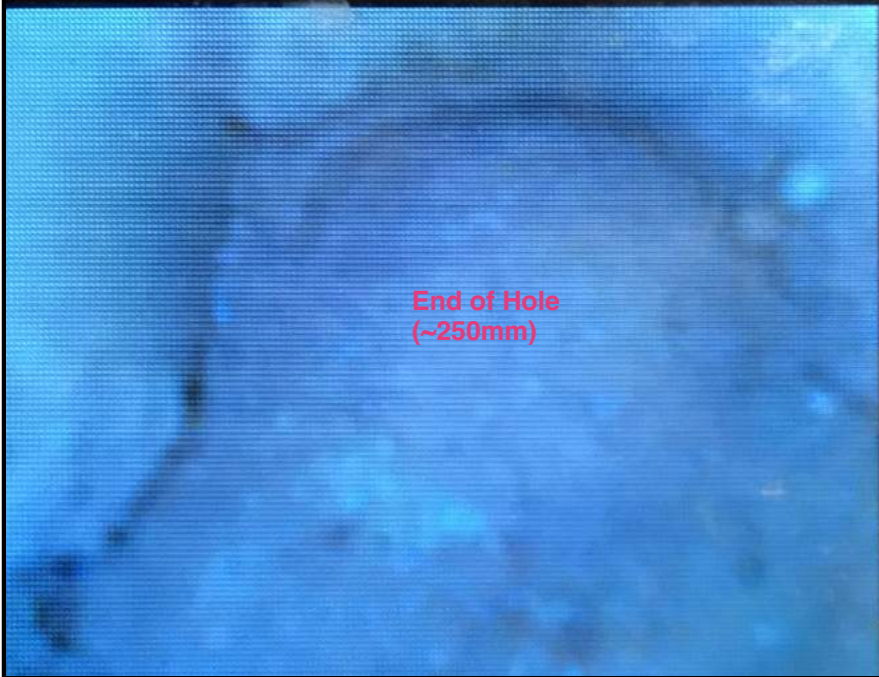
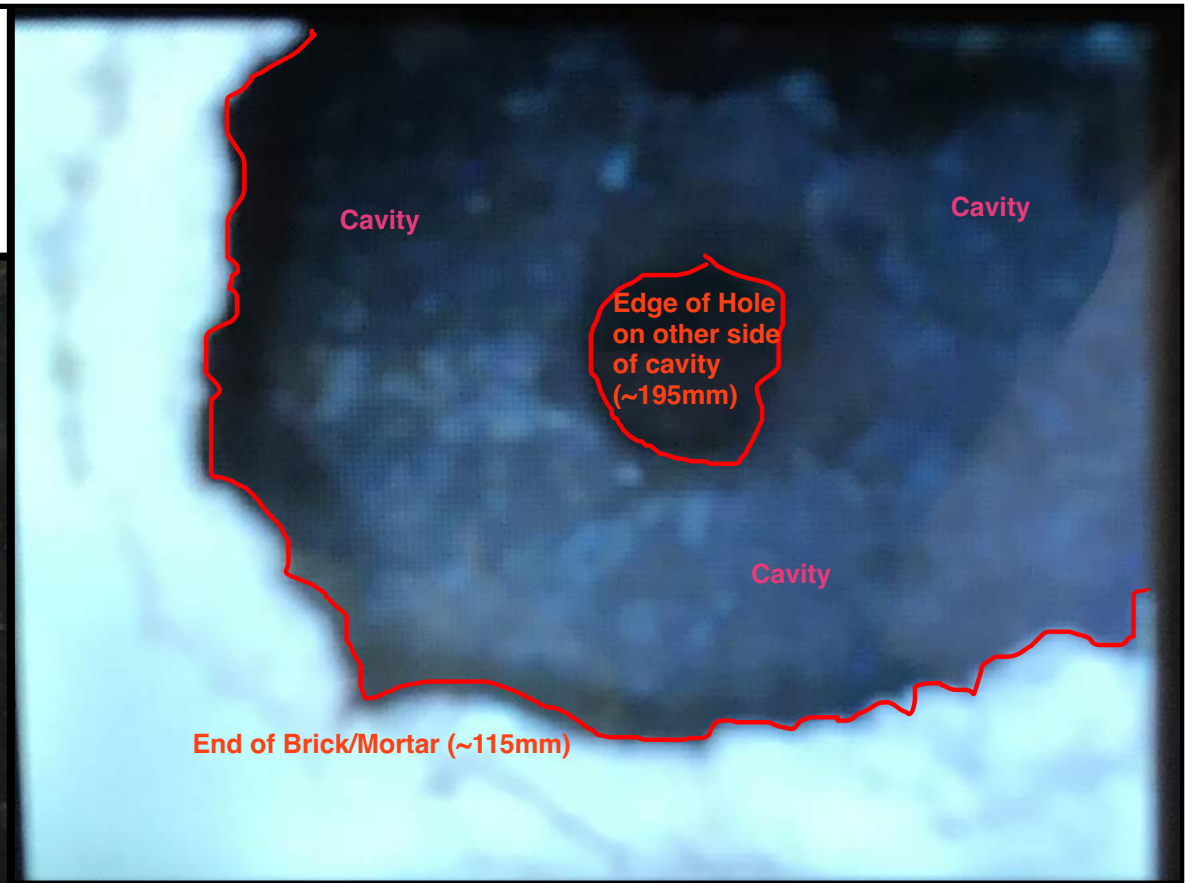
#### Camera Inspection 9

~0-115mm appeared to be solid brick (no voids or cavities seen)

~115-195mm appeared to be a cavity

~195-250mm appeared to be solid brick

~250mm end of hole

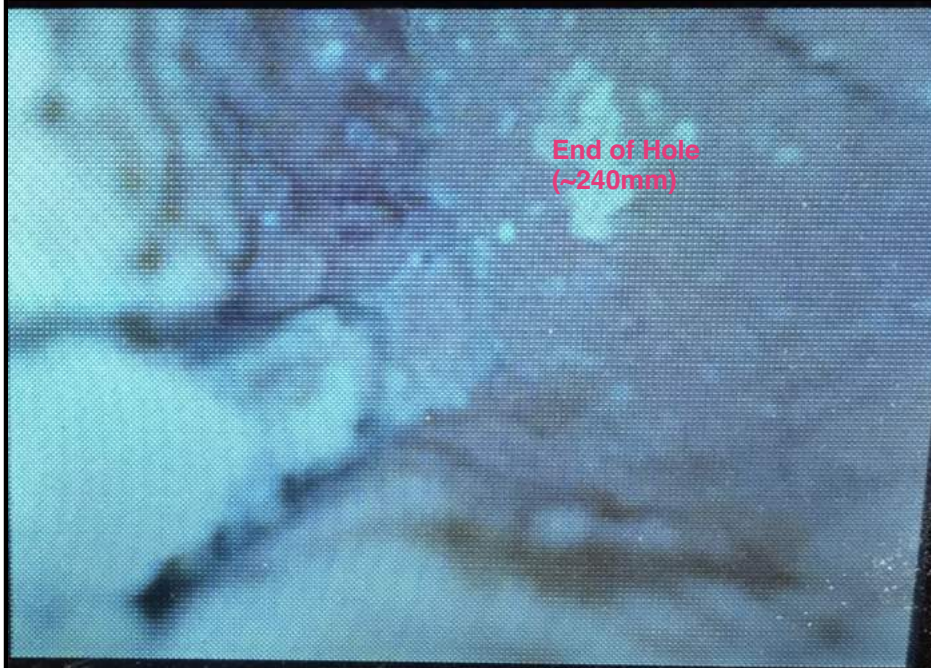
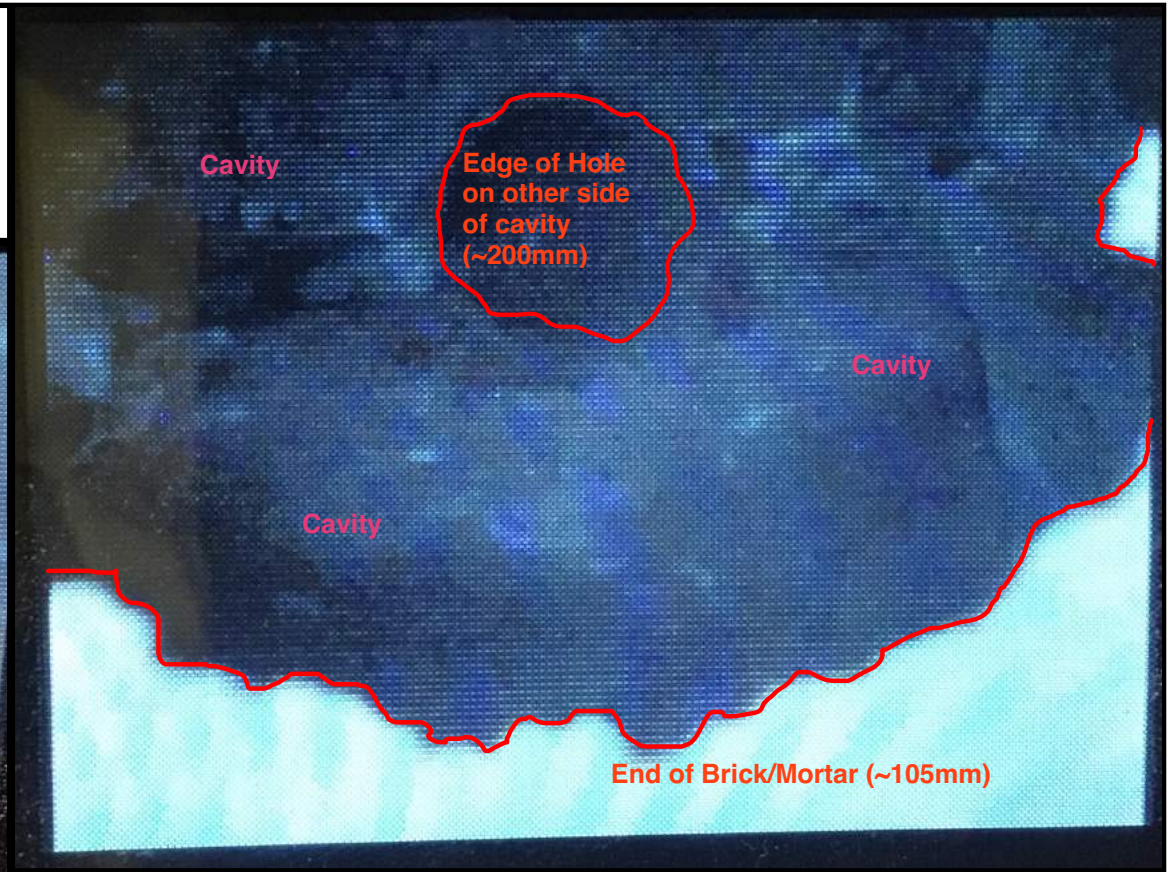
#### Camera Inspection 10

~0-105mm appeared to be solid brick (no voids or cavities seen)

~105-200mm appeared to be a cavity

~200-240mm appeared to be solid brick

~240mm end of hole

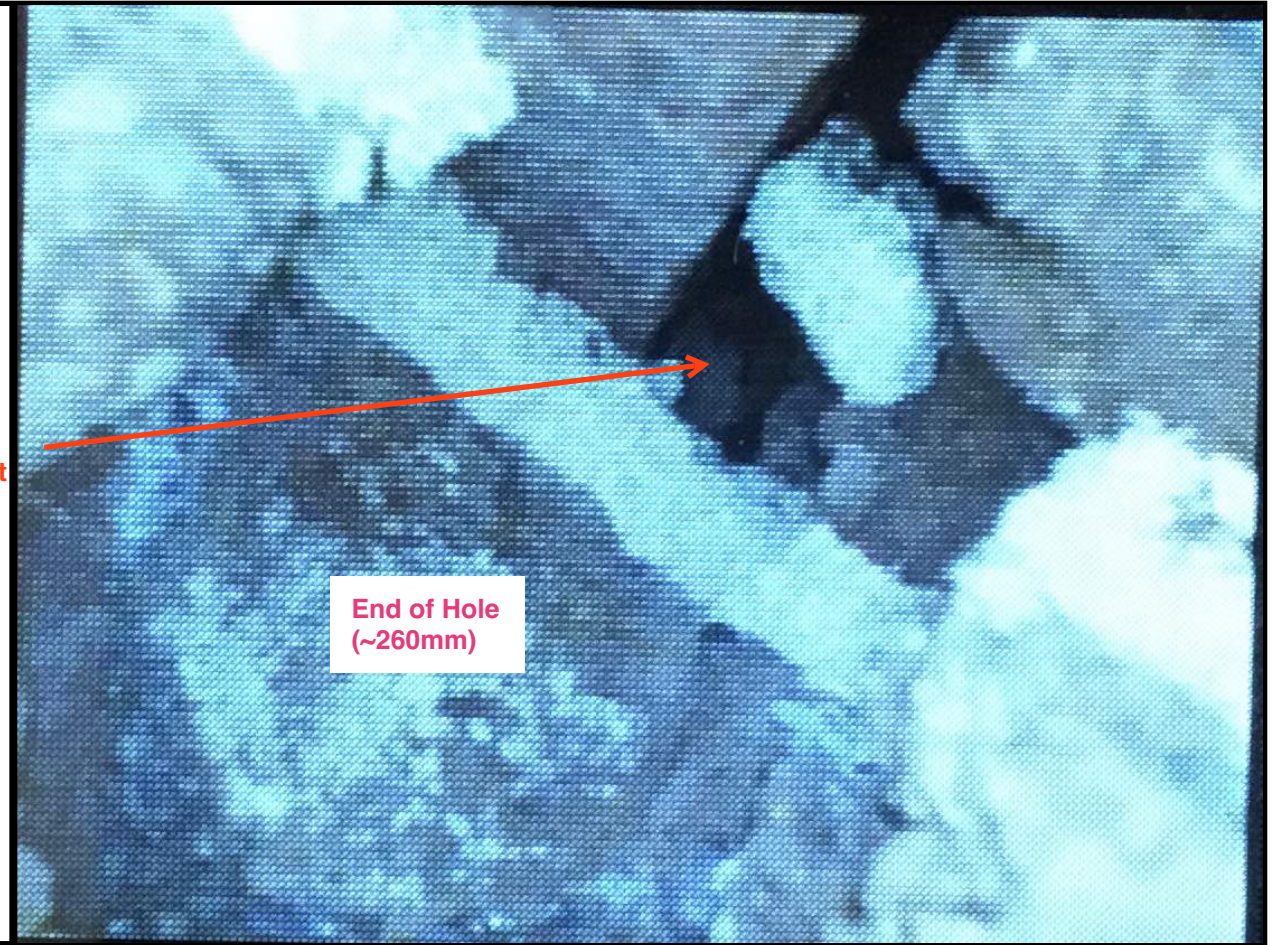
#### Camera Inspection 11

~0-260mm appeared to be solid brick (no voids or cavities seen)

~260mm end of hole

**Note that there appears to be a cavity beyond drilling extent (not large enough for camera access)**

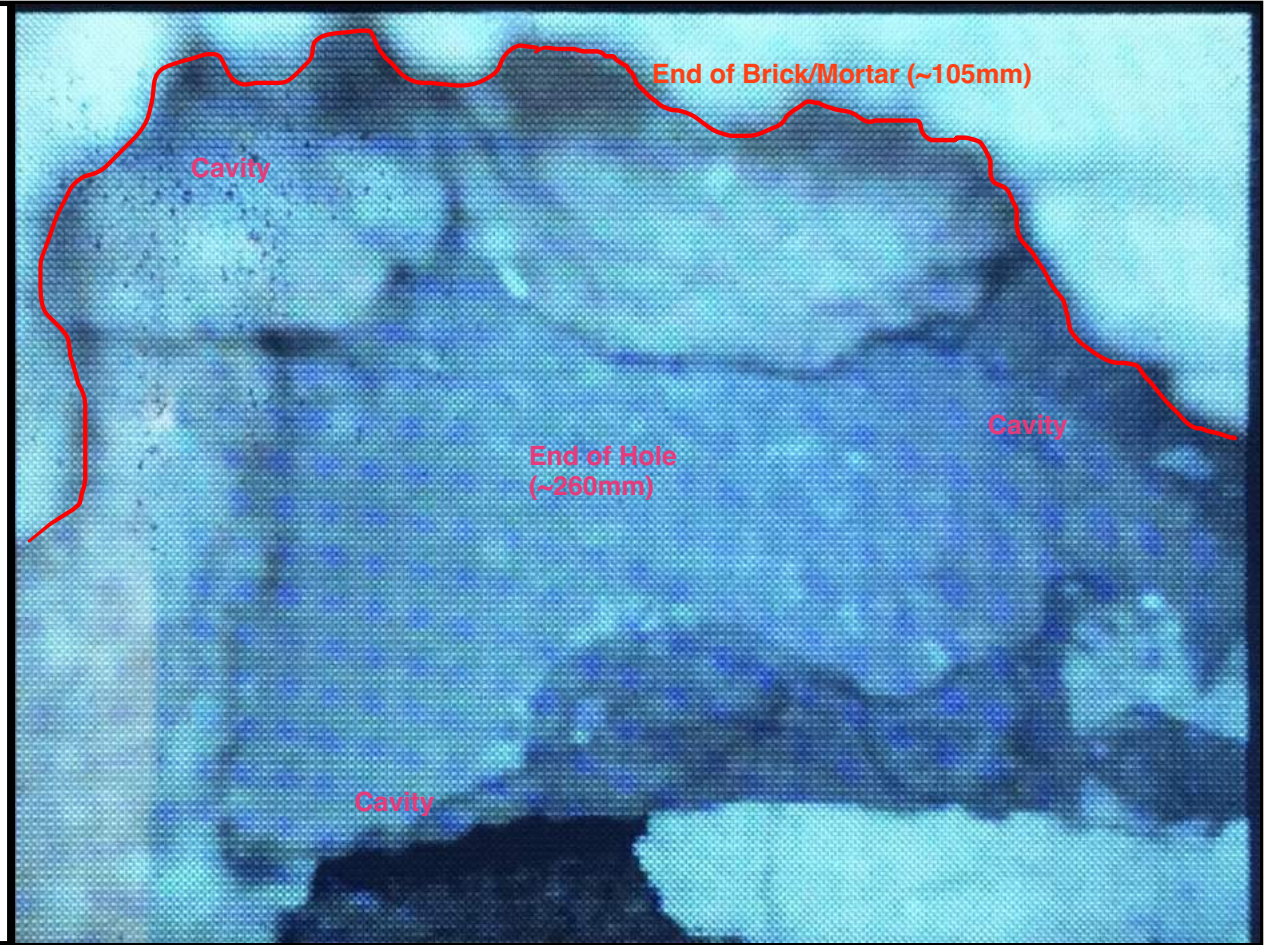
#### Camera Inspection 12

~235-260mm appeared to be a cavity

~260mm end of hole (more brick visible)
