UNITED SCANNING
SERVICES PTY LTD

Concrete Scanning Report

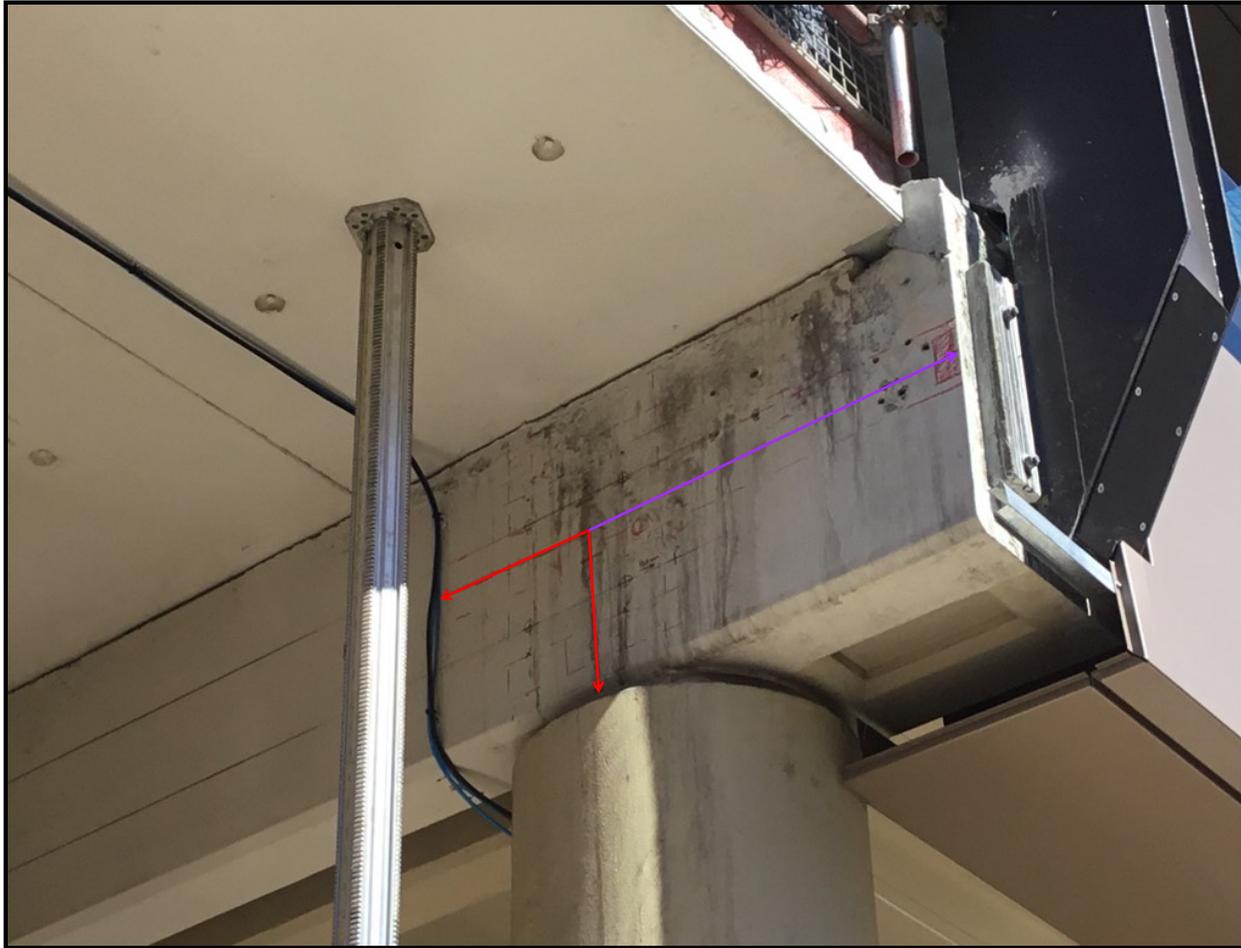
Pictured left is the first area scanned. This area was scanned to detect and make the downpipes in the concrete beam. The red arrows show the detected location of the down pipe (centre). The purple arrow shows the approximate location of another known down pipe however this could not be detected whilst GPR scanning. Although the centre of the beam in this location is solid and should therefore give clear images it was noticed that the centre of the beam appeared to be a different density (possibly a separate pour) and therefore led to scan files being extremely unclear and cluttered past 200mm deep. Through measuring and visually inspecting the entry points of the downpipe into the beam a likely location of the down pipe was marked (with an extra 25mm added on to each side to allow for errors in measuring).
