## Concrete Scanning Report

## 1. Scanning Results

### **Description of Works Completed:**

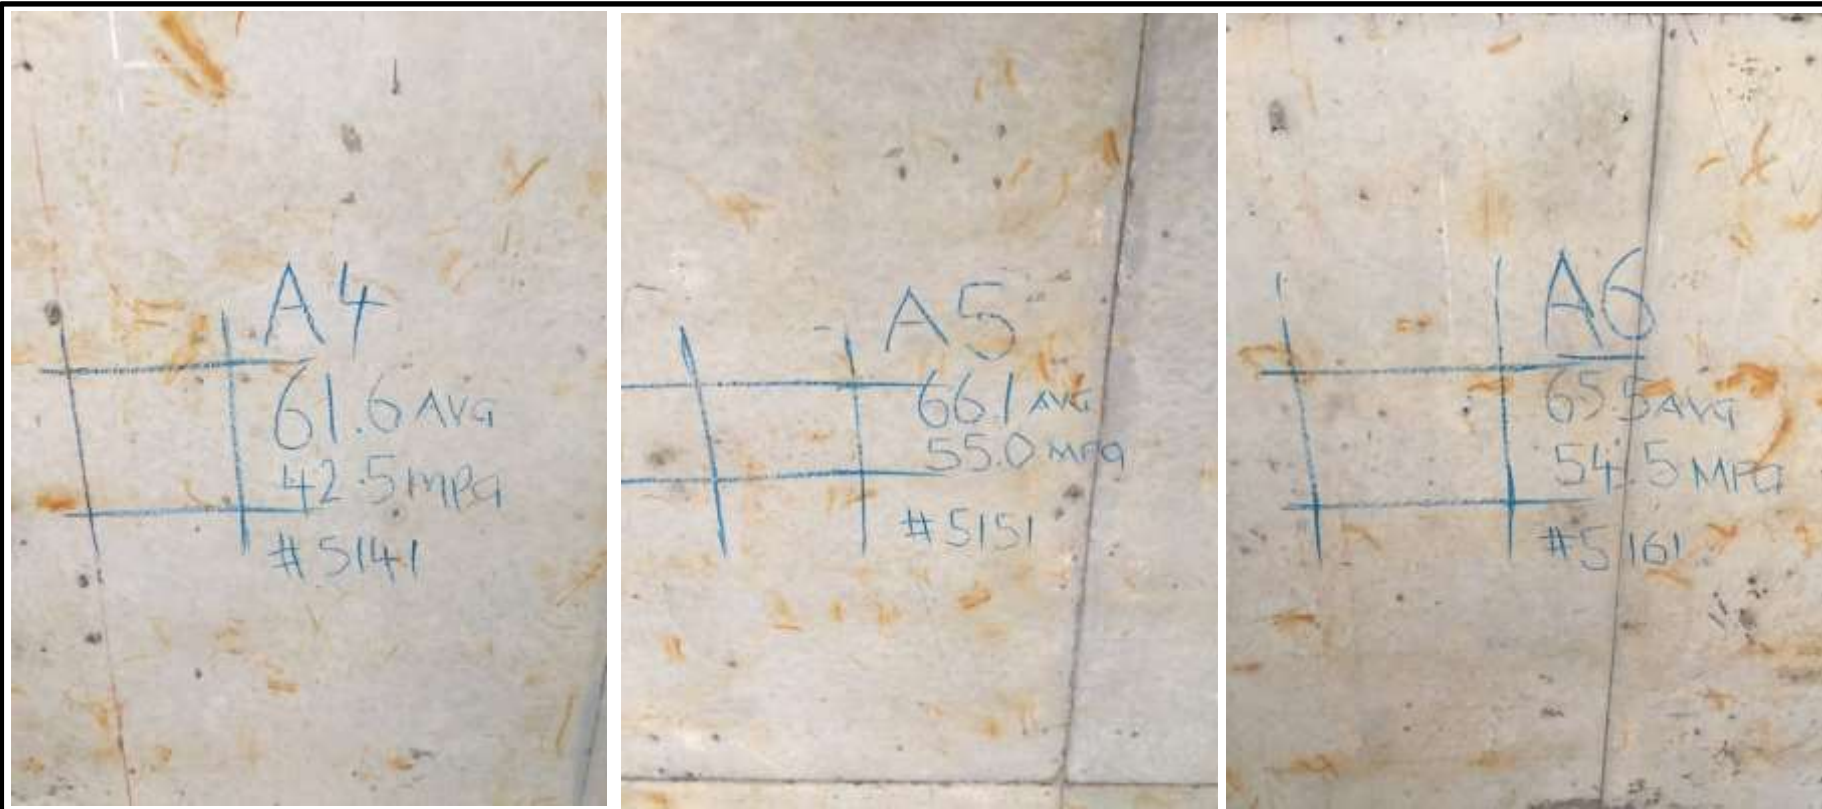
A4, A5, A6 Testing has been conducted on the underside of the balcony slab, testing locations have been taken left to right looking towards the front of the property

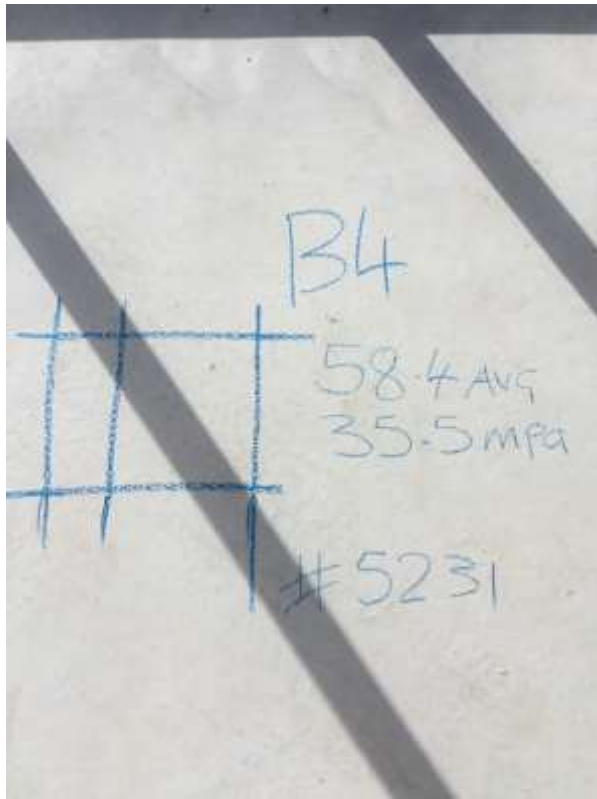
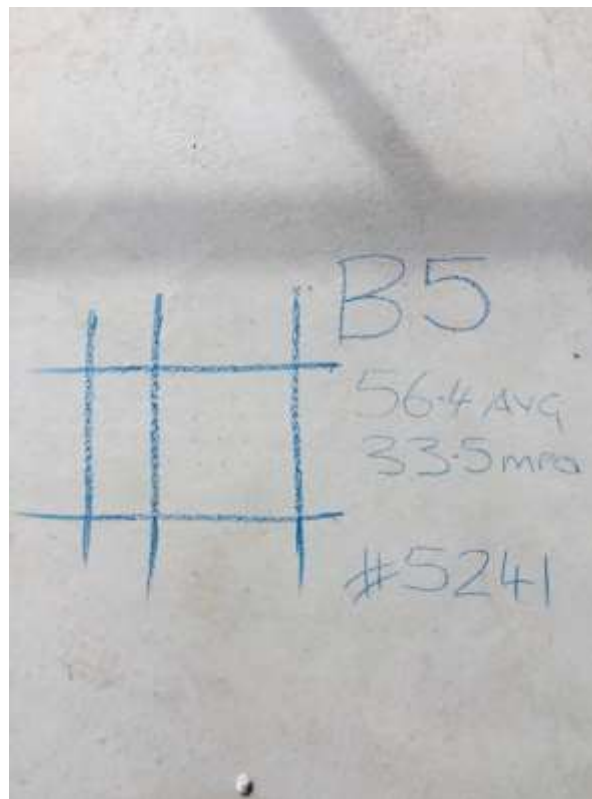
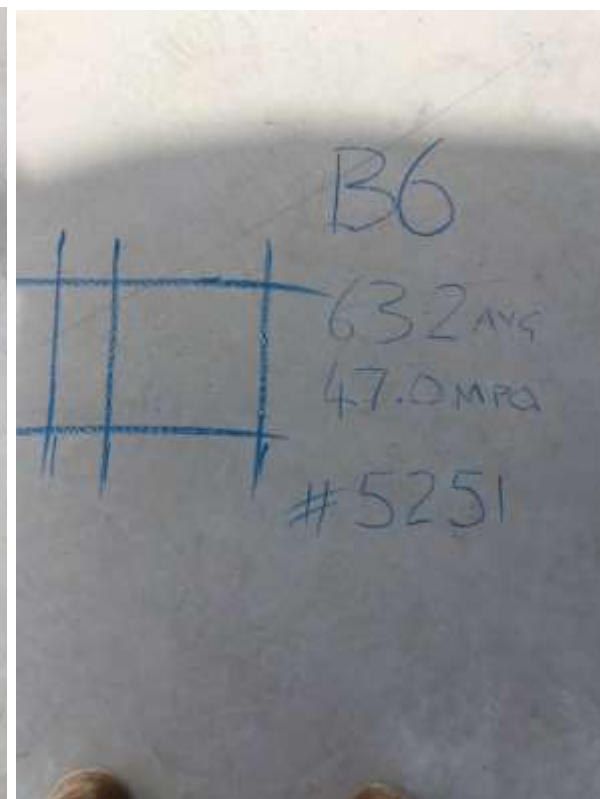
B4, B5, B6 Testing has been conducted on the topside of the balcony slab, testing locations have been taken left to right looking towards the front of the property
